## Medical Device Correction

**Subject: Potential Risk of fluid ingress associated with Welch Allyn® GS777 Wall Transformer (all models) and Connex® ProBP™ 3400 (handheld, desk mount, wall mount models)**

**FSCA-identifier:** MOD1329

**Date:** April 22, 2021

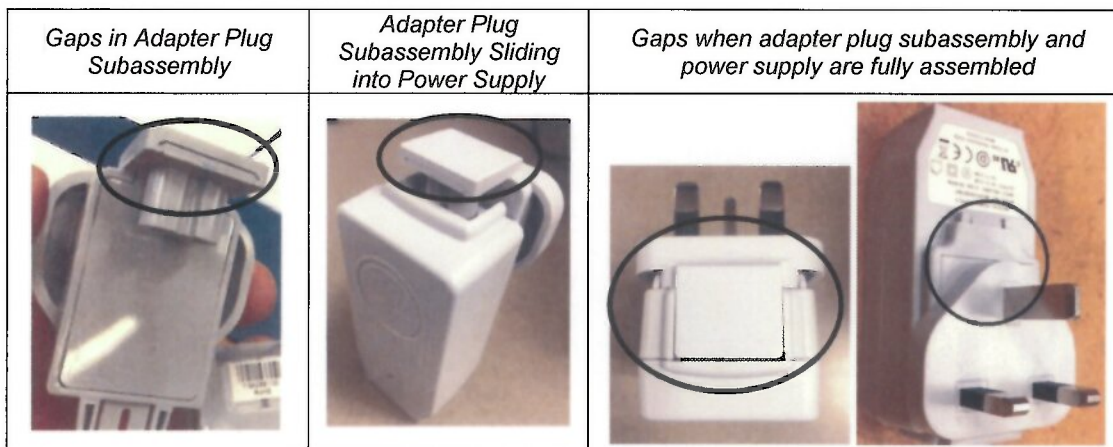
Our investigation has confirmed that the reported complaints were the result of unintentional fluid ingress into the power supply caused during cleaning.

Based on our investigation, unintentional fluid ingress is most likely to occur in the gaps of the adapter plug subassembly pictured below.

The GS777 and the Connex ProBP 3400 power supplies are not intended to be cleaned with saturated wipes and should not be plugged into an electrical outlet when wet.

1. Unplug the power supply from the outlet.
2. Make sure the cleaning cloth is not soaked (not dripping or over saturated) with cleaning fluid.
3. Apply minimal pressure on wipe when cleaning; avoid wiping gap areas identified on adapter plug as these areas are most susceptible to liquid ingress.
4. Make sure the power supply and power cord are dry before plugging into electrical outlet.
5. Hold the sides of the power supply when plugging into electrical outlet as pictured below.

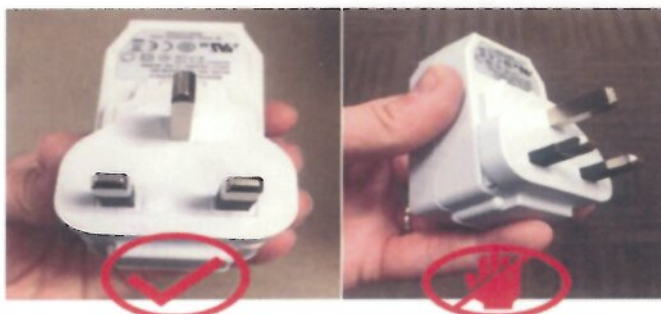
Avoid contact with bottom of the power supply where cleaning fluid is mostly likely to have accumulated.
