## Medical Device Correction

**Subject: Potential Risk of fluid ingress associated with Welch Allyn® GS777 Wall Transformer (all models) and Connex® ProBP™ 3400 (handheld, desk mount, wall mount models)**

**FSCA-identifier:** MOD1329

**Date:** April 22, 2021

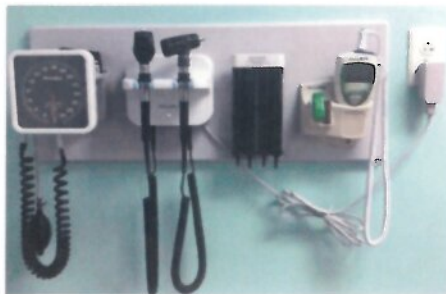
GS777 Wall Transformer

There is a risk of an internal electrical short and possible electrical shock occurring if cleaning fluid ingresses into the power supply, and the power supply is plugged into the electrical outlet before the cleaning fluid has completely dried. This notice is being distributed to make users aware of this potential risk and provide instructions for appropriately cleaning the power supply.

Hillrom has received 10 complaints regarding electrical shorts in the adapter plug assembly when plugging the power supply used with Welch Allyn GS777 Wall Transformers and Connex ProBP 3400 Mobile Blood Pressure Devices into an electrical outlet. To date, we are aware of one reported injury associated with this issue.

Our investigation has confirmed that the reported complaints were the result of unintentional fluid ingress into the power supply caused during cleaning.

**To minimize risk of potential electrical shock be sure to follow these cleaning recommendations:**
